8 FORTA

REINFORCEMENT THAT LASTS

FORTA-FI®

REINFORCED ASPHALT WORK?

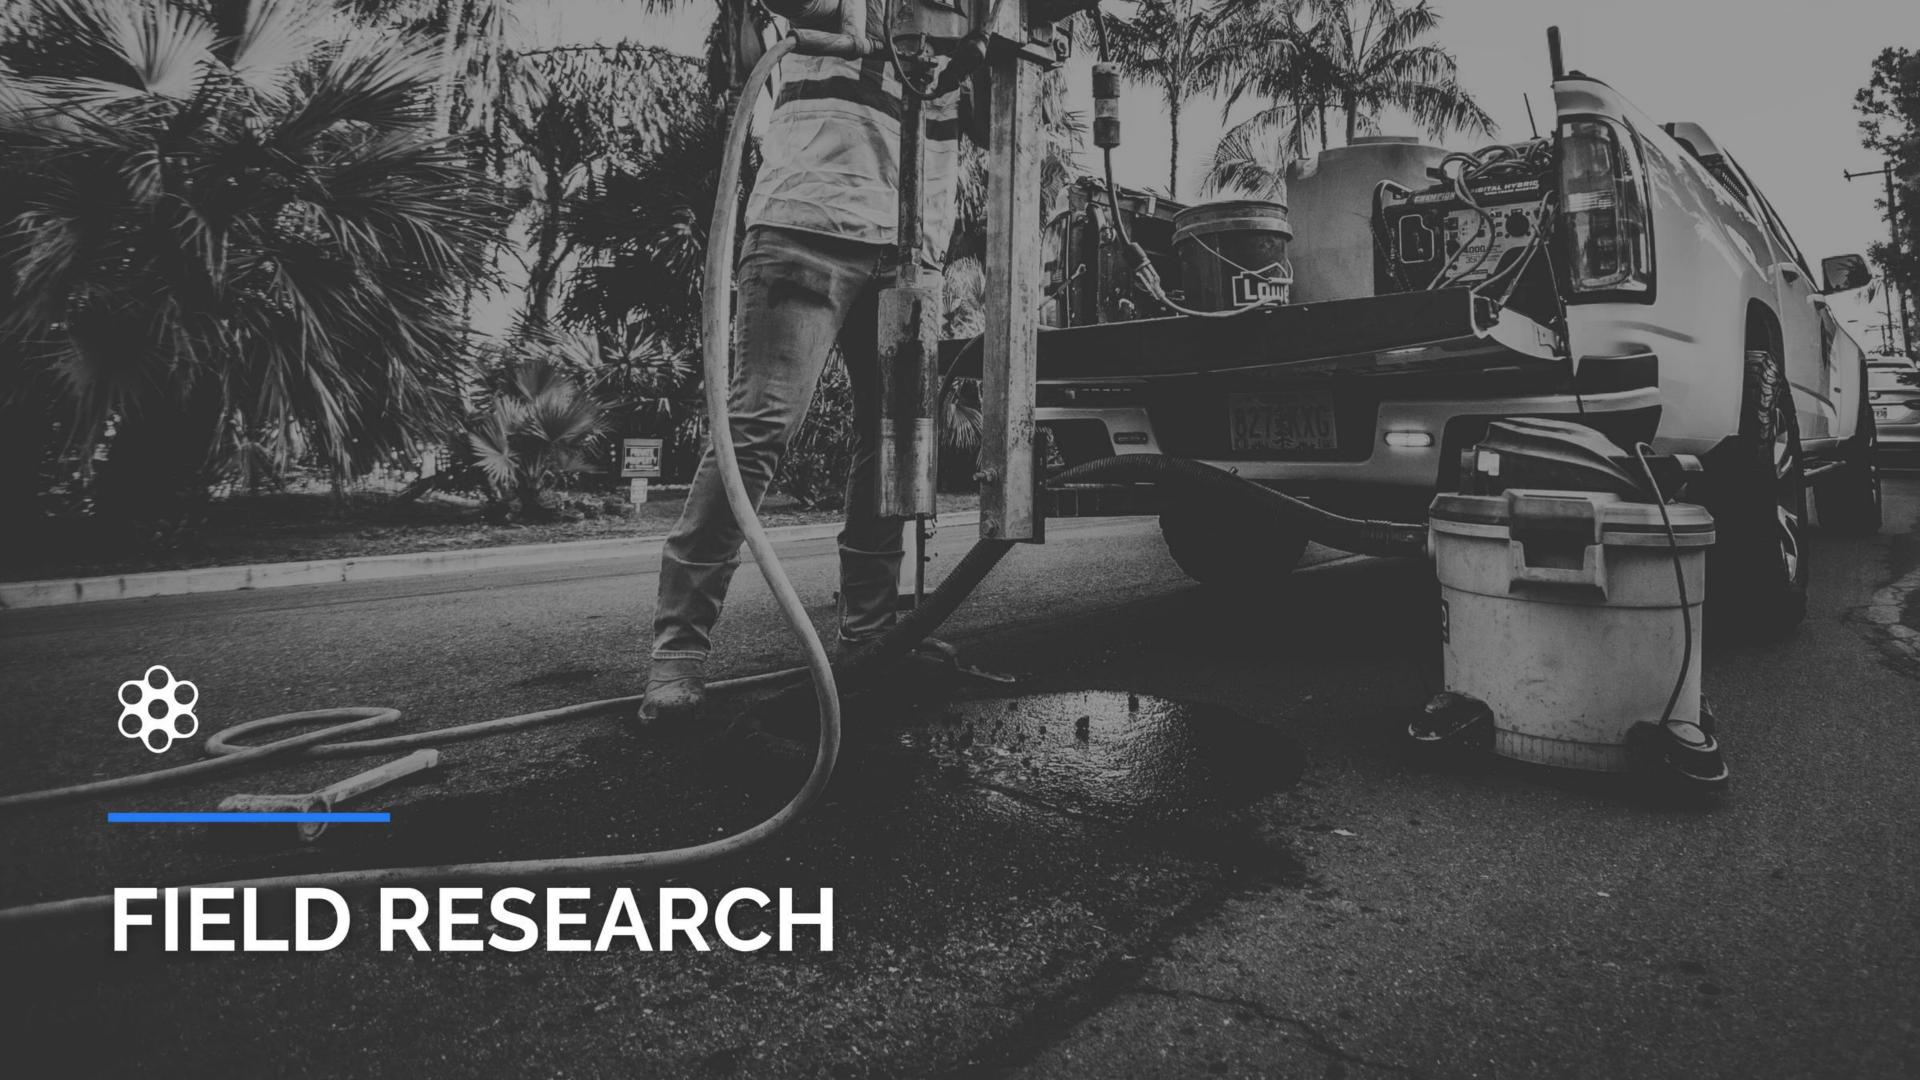
CONTROL VS FIBER NEW YORK DOT

CONTROL

6-in Joint Repair Dig Outs, Polymer Modified Binder (PG 64V-22), 2-in Mill & Overlay

FIBER REINFORCED ASPHALT

2-in Mill & Overlay, Neat Binder (PG 64S-22)

FRAC Section Significantly Outperformed; Further Adoption from NYDOT

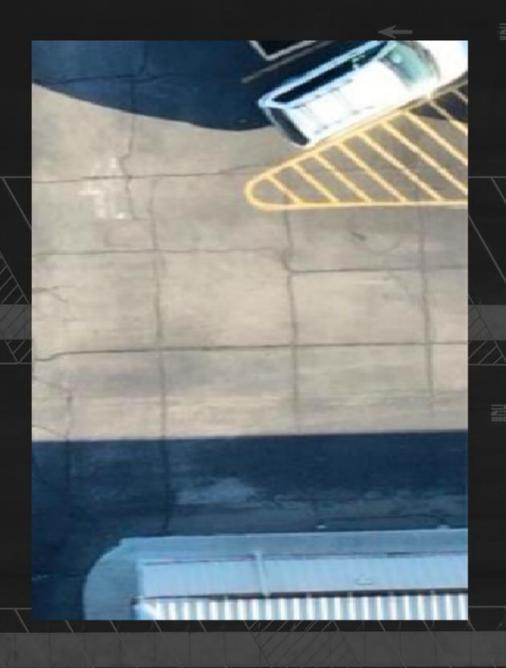
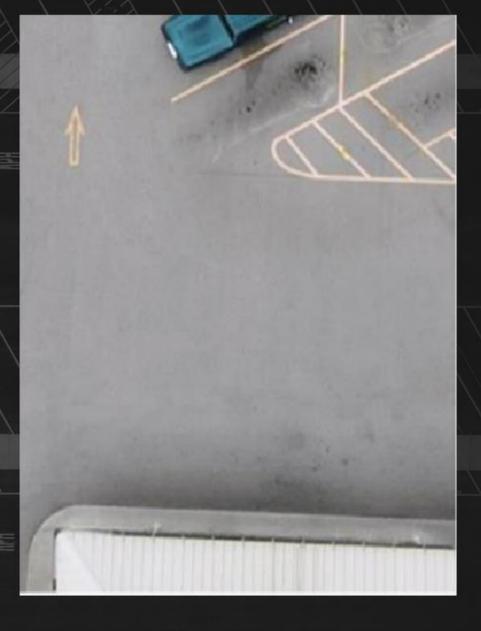
B FORTA*fied*™

3 Year Unreinforced

FORTA*fied* ™ 3 Year Fiber Reinforcement

3 Year Comparison – Same Location > 100 °F

Cracking Significantly Improved, Extended Lifespan

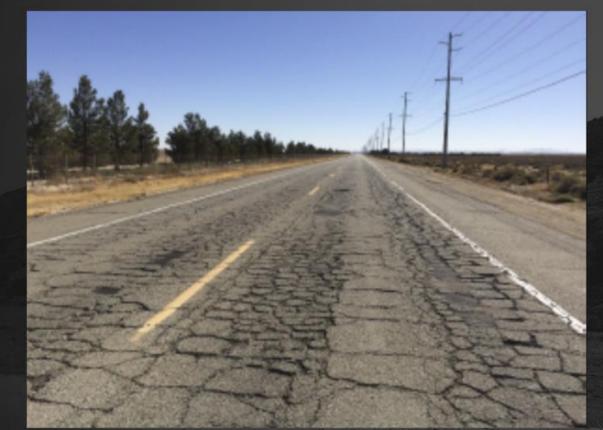
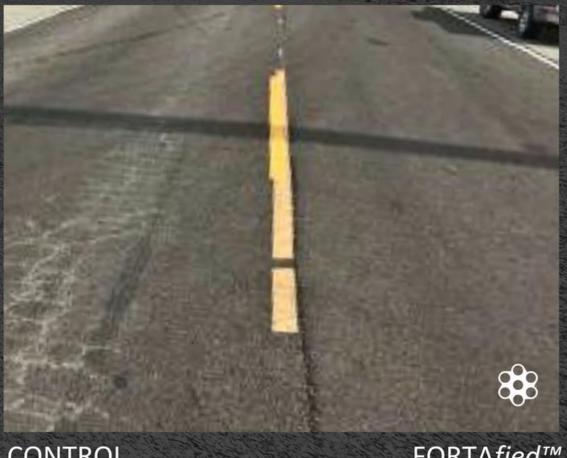
Asphalt Destroyed, Reconstruction Needed, > 100 °F

2 INCH OVERLAY

AFTER BEFORE

CONTROL

FORTA*fied™*

Side-by-side Showed Significant Benefit from Fiber, but will Still Fail

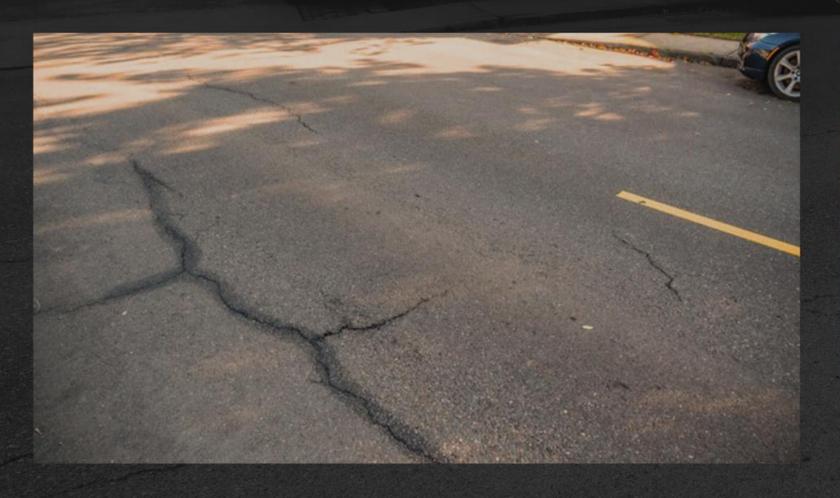
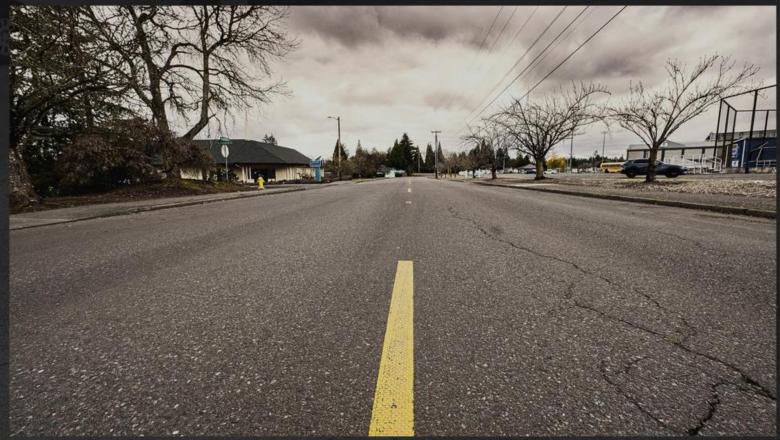
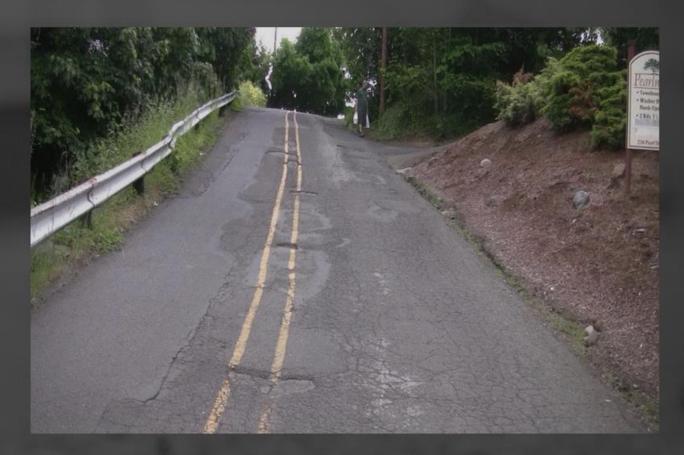
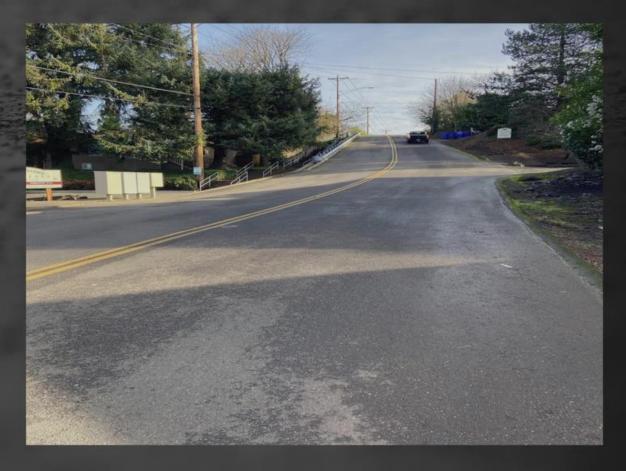
63% Less Cracking

Since 2013, the control lane has received a crack seal treatment and continues to show cracking, while the reinforced side holds strong with no crack seal treatment needed.

CONTROL

FORTAfied™ 2 INCH OVERLAY

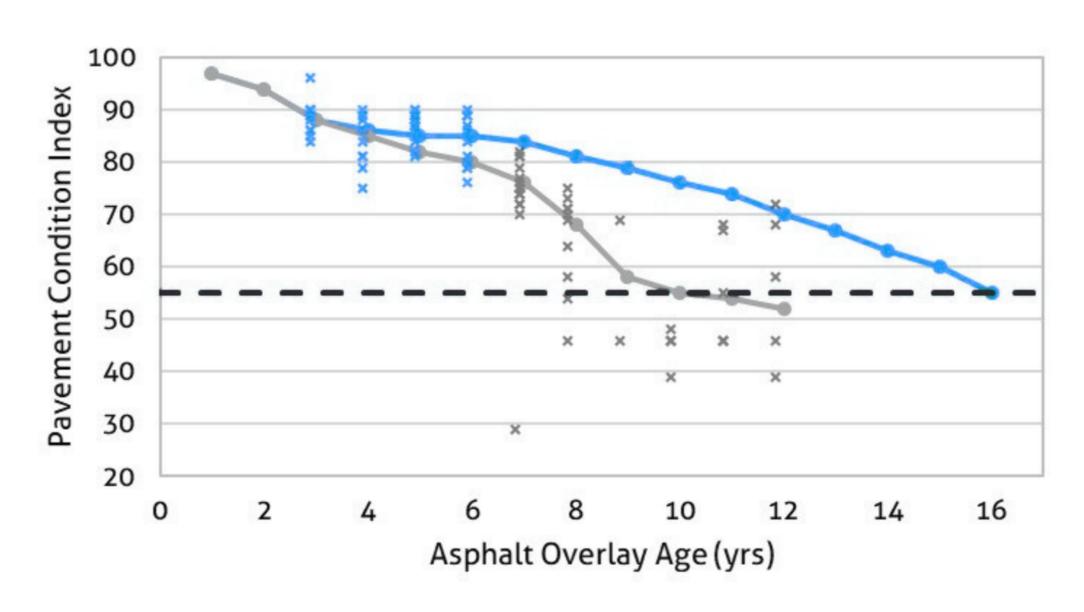
93 SEGMENTS EVALUATED

43 Conventional 50 Fiber Reinforced Asphalt

Conventional Average Lifespan: 10 Years Fiber Reinforced Average Lifespan: 16 Years

Conventional HMA Deteriorates Almost 2X Faster Over First 10 Years

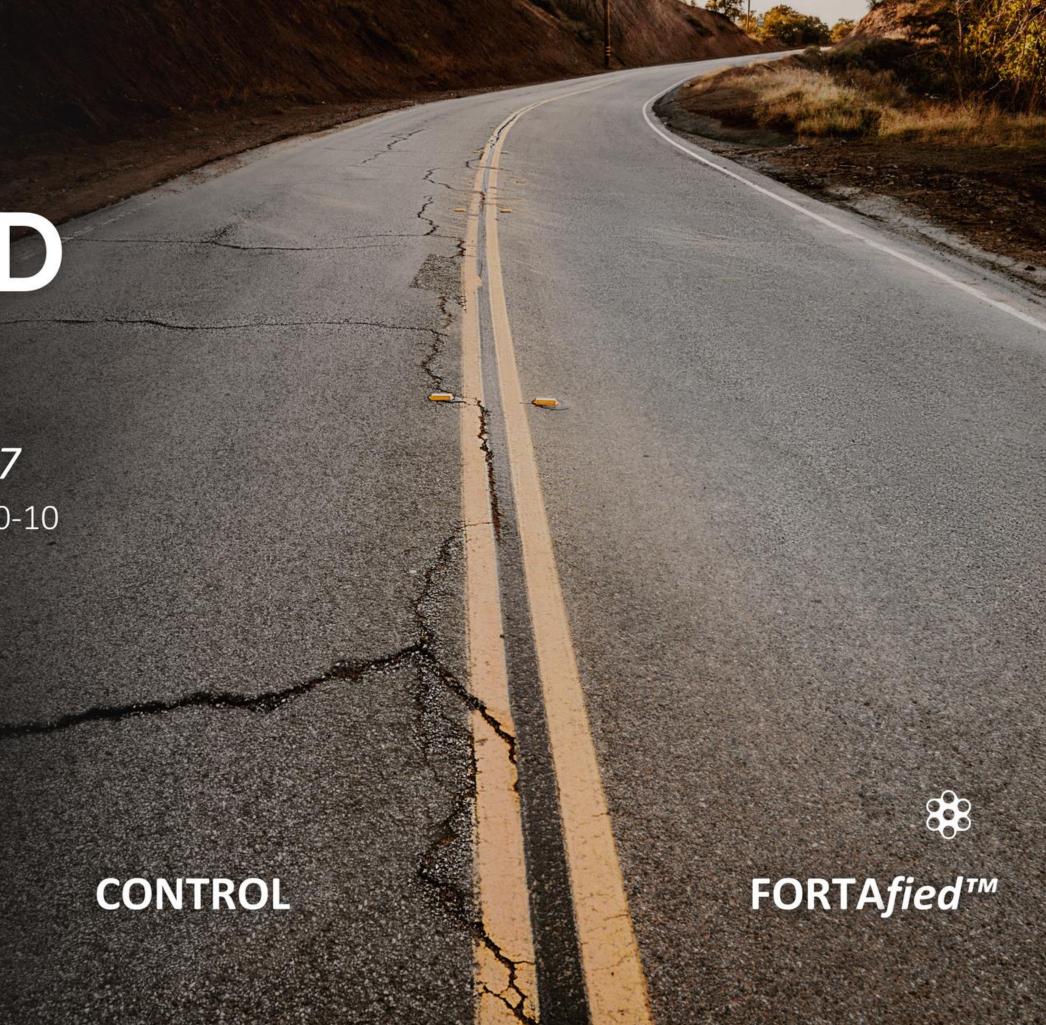
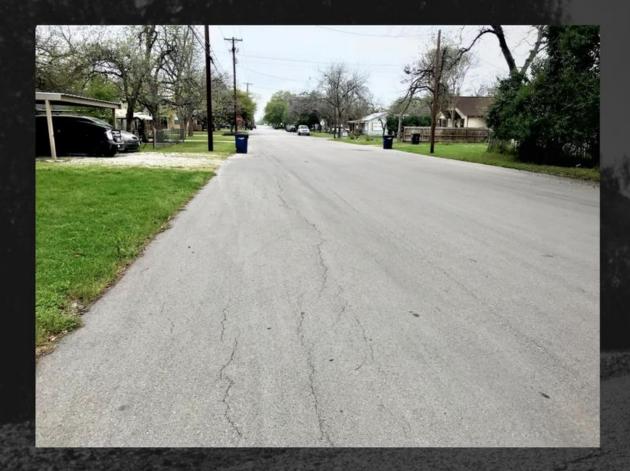
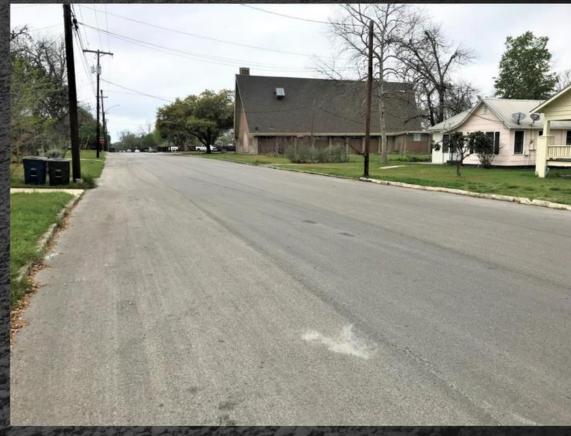
5 Year Evaluation, > 100 °F 2-in Mill and Overlay, PG 70-10

Less Fatigue, Reflective, & Thermal Cracking

CONTROL

FORTAfied™ 2 INCH OVERLAY

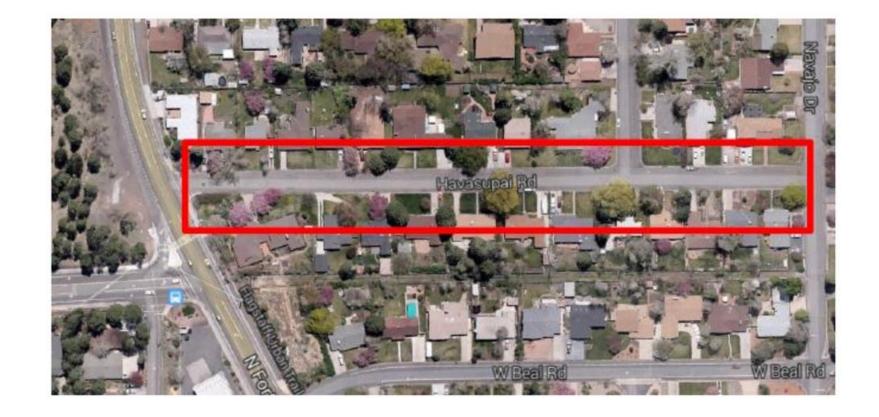
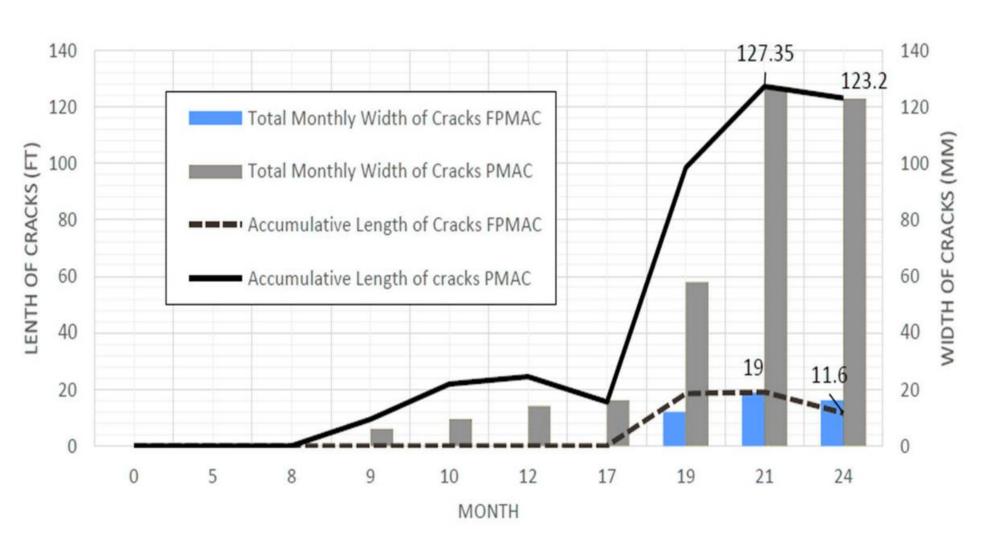
Total Crack Length (90% Less)

Control: 127'

FORTA-FI®: 19'

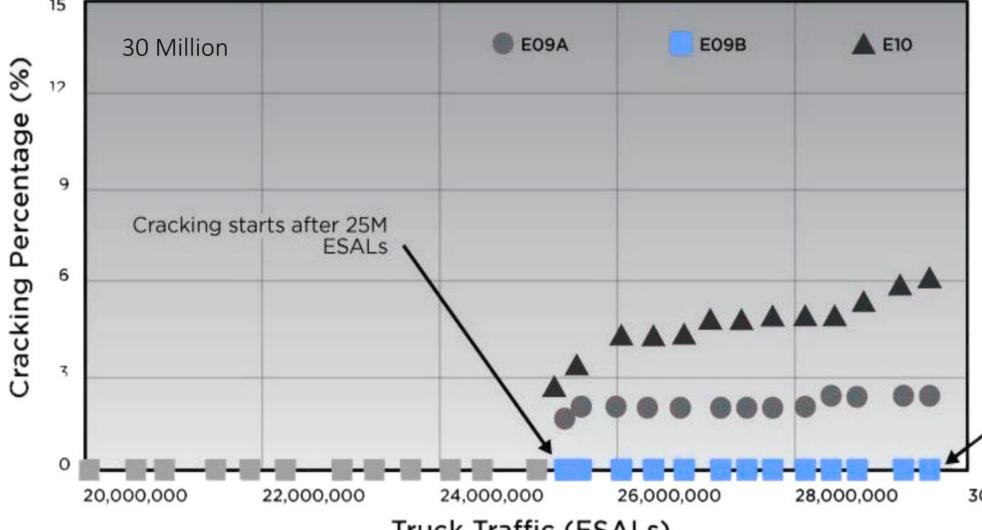
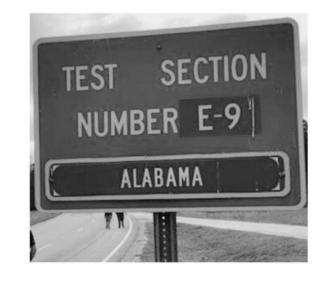
TEST SECTION: E98

The FORTA-FI section was the only section with no cracking after 30 million ESALs.

FORTA-FI section still has no cracking distress 30,000,000

Truck Traffic (ESALs)

NCAT: The National Center for Asphalt Technology (NCAT) just outside of Auburn, Alabama, is a world leader in asphalt research. NCAT is renowned for their asphalt test track that utilizes accelerated pavement testing. During each testing cycle, 10 million ESALs (about 10 years of traffic) can be applied to the track in only several years. There are 46 different test sections on the track and each one is accurately monitored using temperature probes, a wireless mesh network, strain gauges, and pressure plates where applicable.

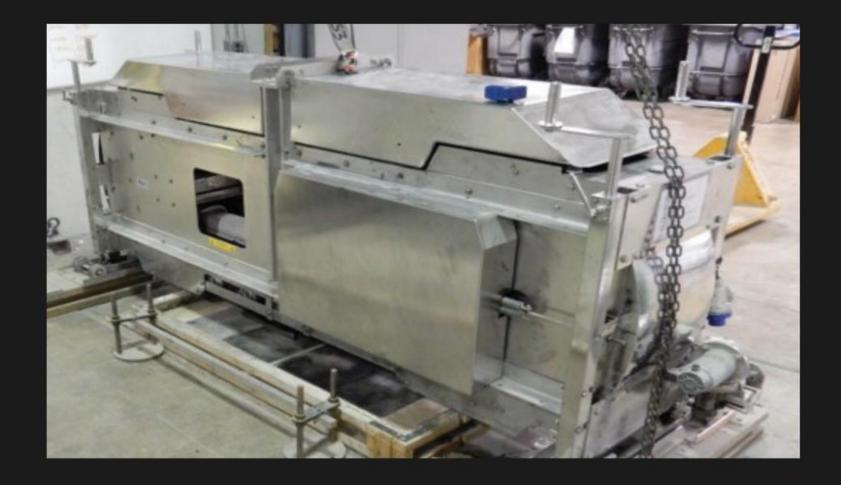
Following 300,000 cycles, neither the control or FORTA-FI samples exhibited cracking or rutting. The loading speed was then reduced for an additional 25,000 cycles. The reduced loading speed caused significant rutting in the conventional mix while the FORTA-FI reinforced section exhibited 50 percent less rutting.

50% Less Rutting with FORTA-FI®

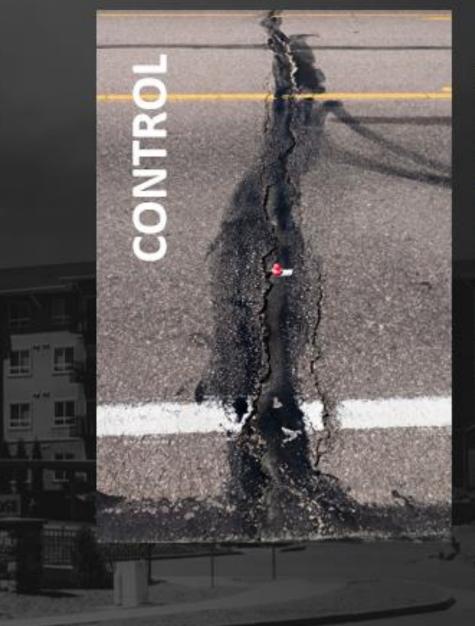
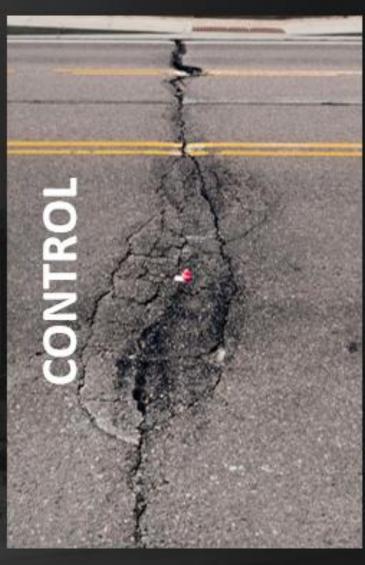
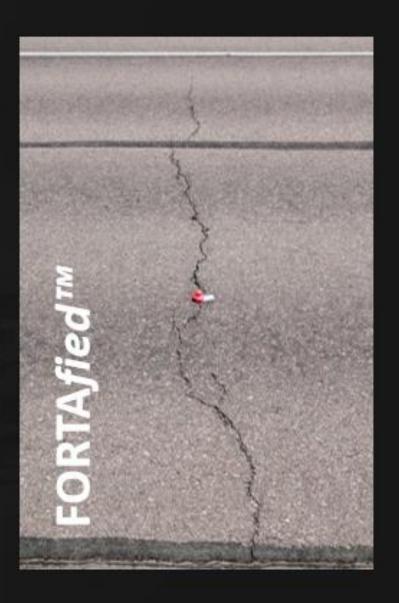
THERMAL CRACKING WIDTHS

Avg Crack Width

Max Crack Width

Twice as Many Thermal Cracks than the FORTA-FI Section
