Replacement of County Route 24 over Grasse River

Responding to a Community in Need

Don Chambers – St. Lawrence County Department of Highways

Bryan Tremblay, P.E. – Barton & Loguidice, DPC

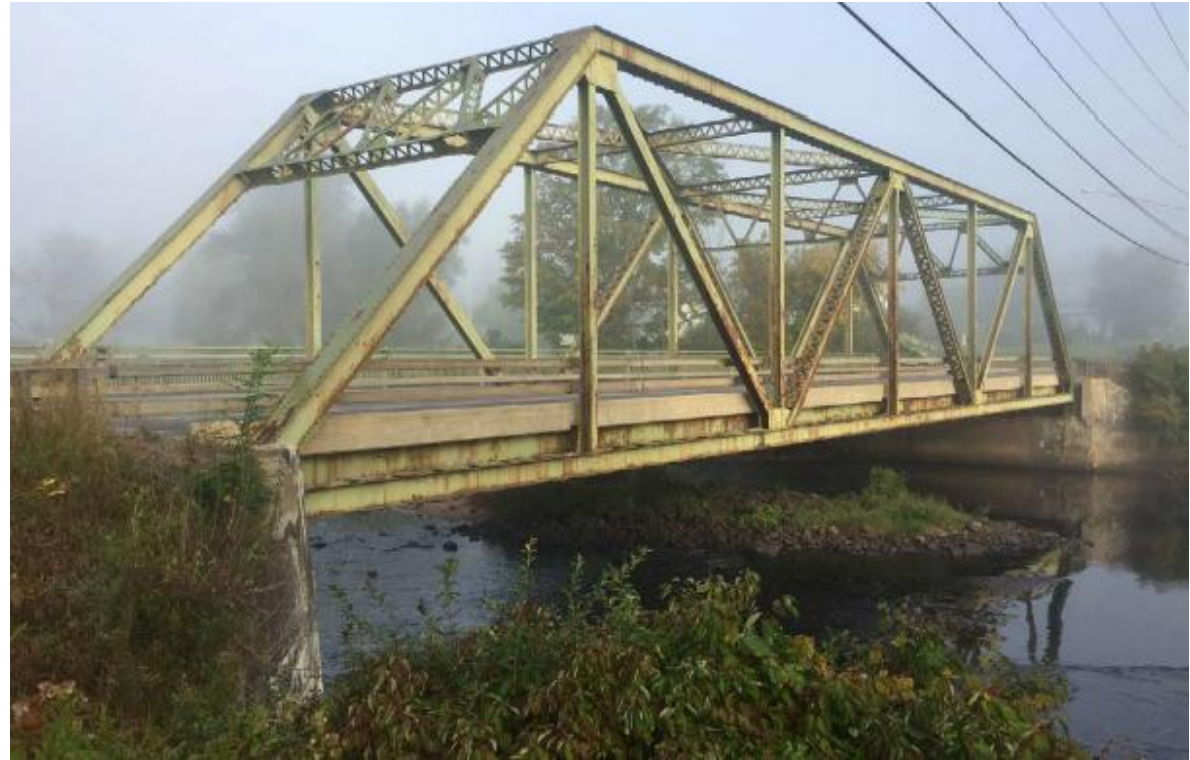
Project Background

- 150' long, single span Thru Truss constructed in 1929
- The crossing had undergone at least three deck replacements over its lifetime
- Truss had sustained a number of vehicular impacts
- Vertical clearance of 14'-8"

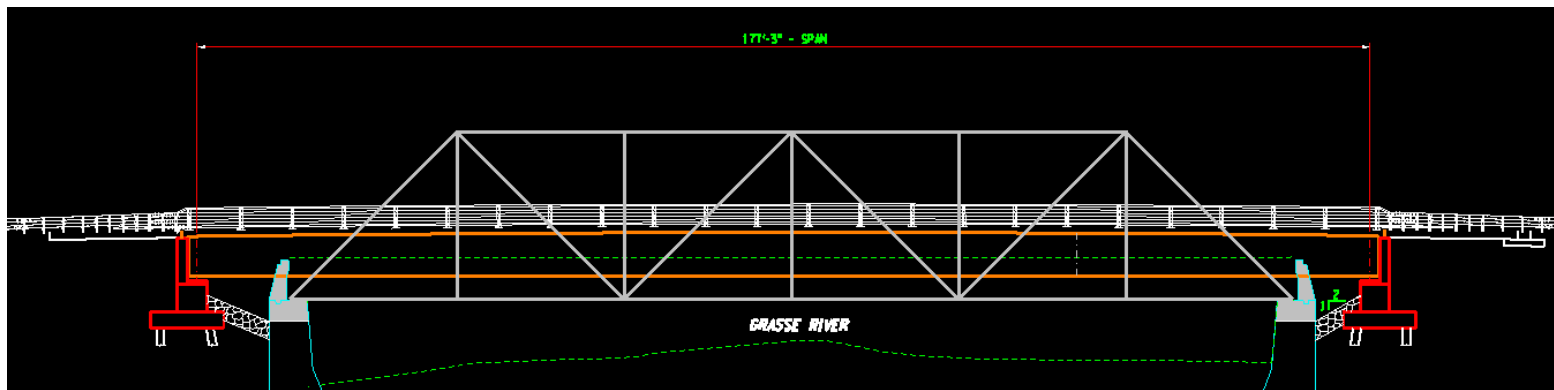
Proposed Bridge

- Single span (177'-3") steel plate girder with a composite concrete deck
 - 70" tall girders
- Piers were considered, but written off due to construction cost and maintenance
- Construct new pile supported abutments immediately behind existing substructures
 - Use existing abutments as scour protection
 - Keep excavation limits above water level to eliminate need for cofferdams

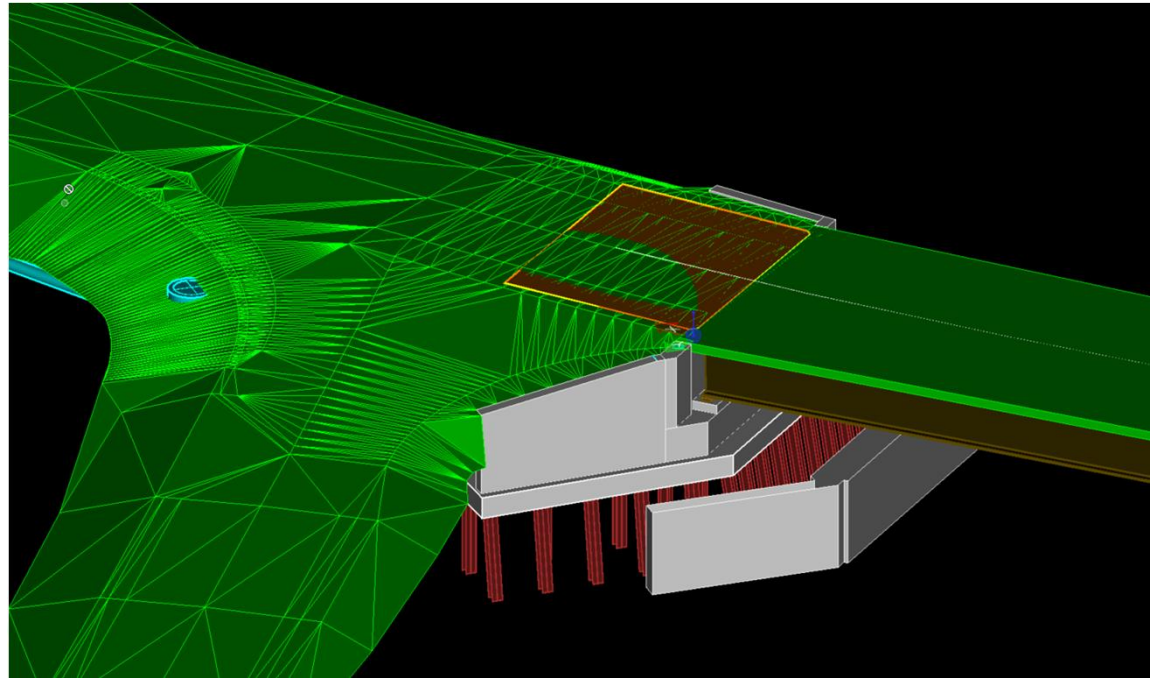
Maximize Freeboard

- Road can be raised approximately 4' while keeping fill limits within existing highway boundary
- 4 rod ROW width (old Military Turnpike)
- Results in the low beam elevation being raised by 13"

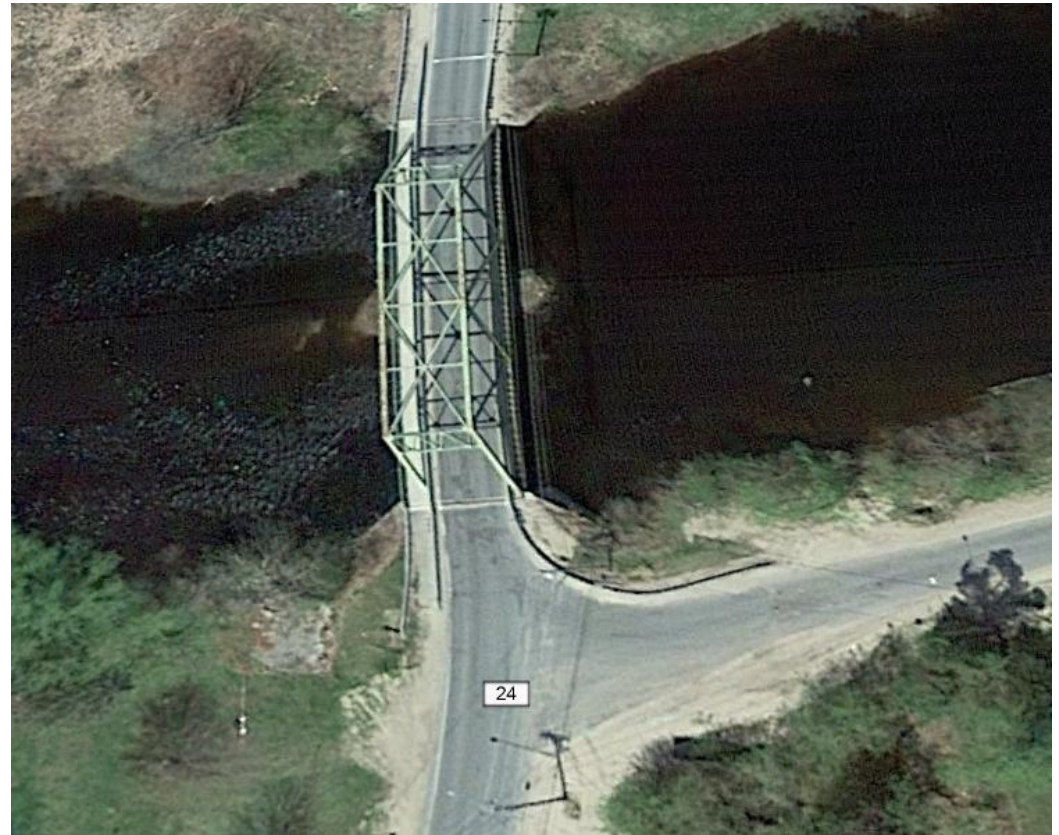
Intersection of Blanchard Hill Road

- Roadway profile raised approximately 4 feet at intersection

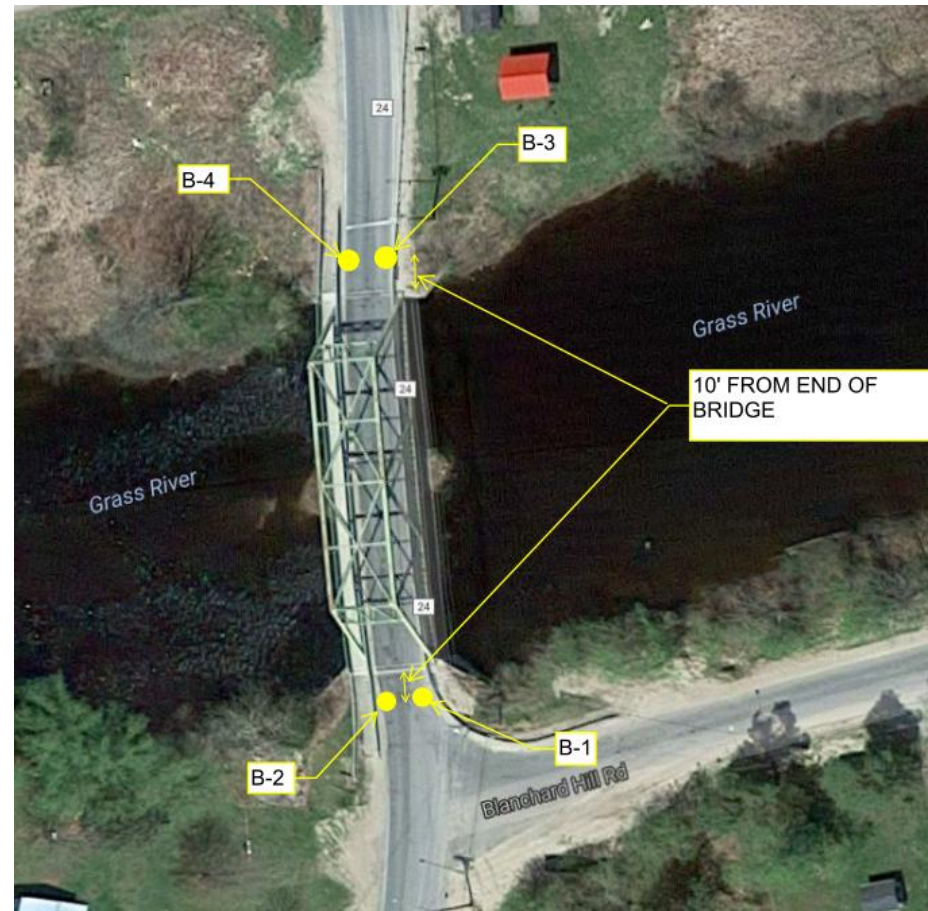
Contaminated Soils

- Soil boring contractor encountered petroleum odors while drilling Boring B-1
 - B-1 was completed, but B-2 was abandoned due to concerns with hitting the same contaminated soils
 - Required that the spill be called in to NYSDEC and that cuttings be treated as contaminated waste
 - Significant change order to deal with contaminated materials
 - Borings B-3 and B-4 completed per scope

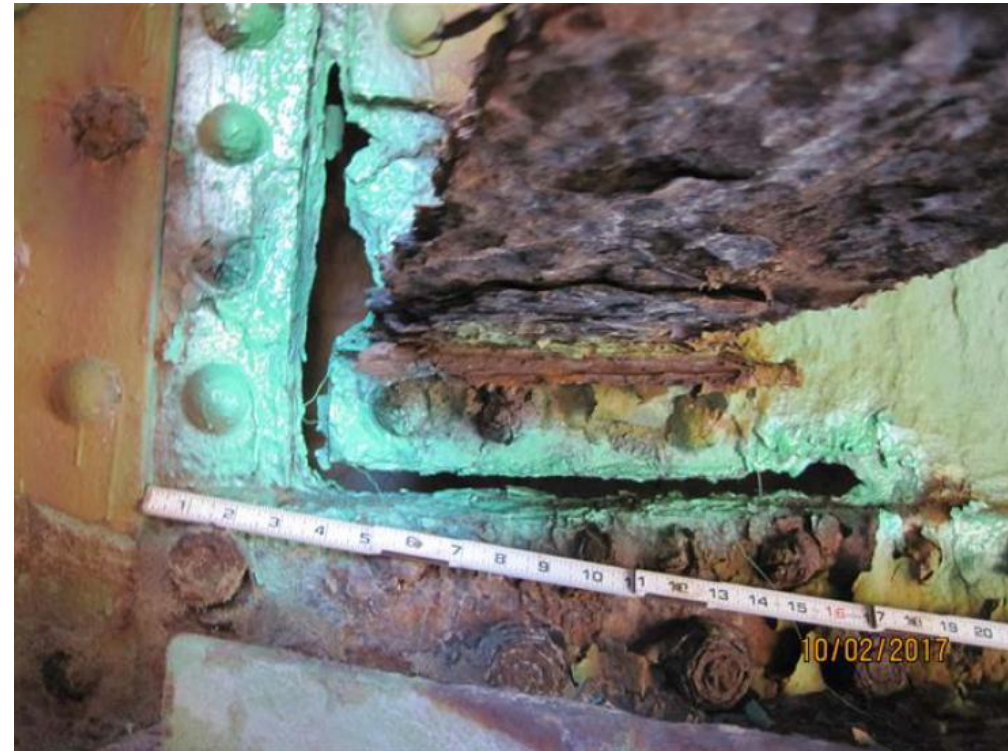
Biennial Inspection

- Flag issued on October 6, 2017
- Same day that draft design approval document was submitted for review
- Connection of upstream fascia stringer into transverse floorbeam

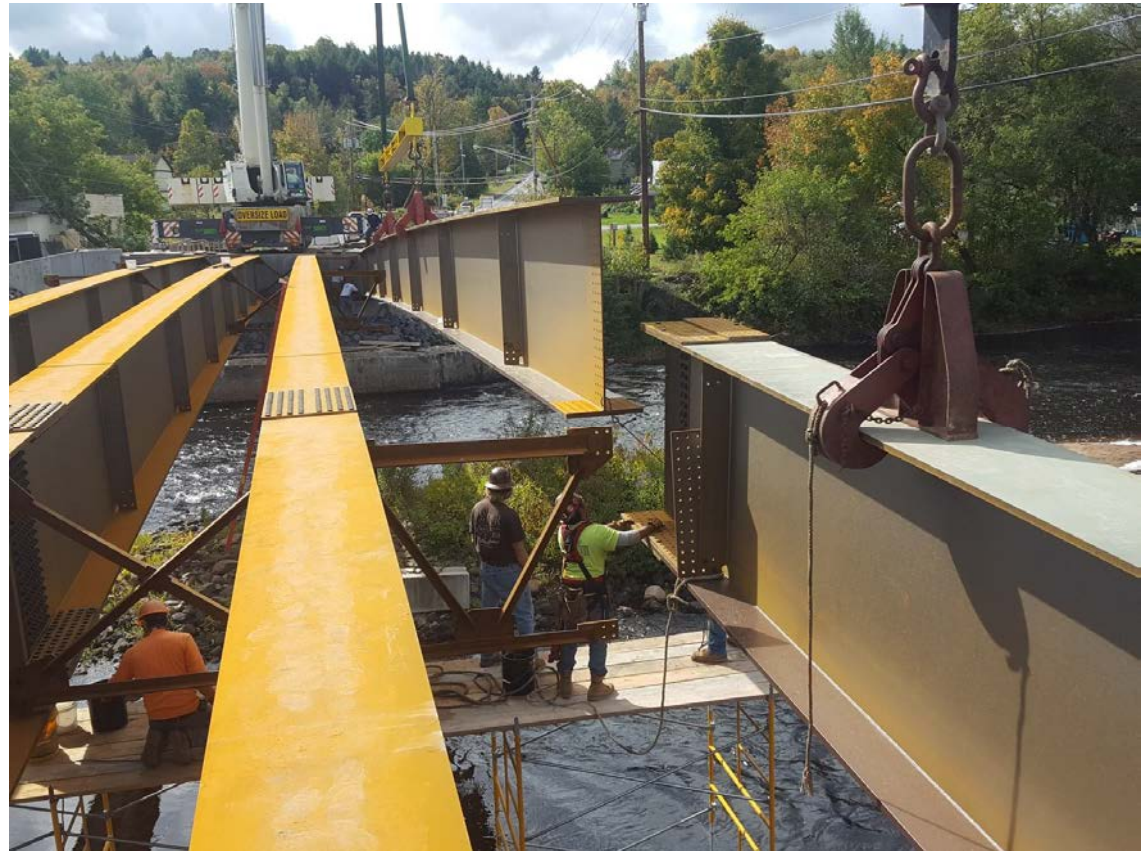
Design Elements

- 178'-5" long steel girders
- Girder split into a 45'-5" and a 133'-0" long pieces with a field splice
- Girders approximately 70" tall
- Over half million pounds of steel
- Need to get out to bid a quickly as possible to ensure delivery in 2018

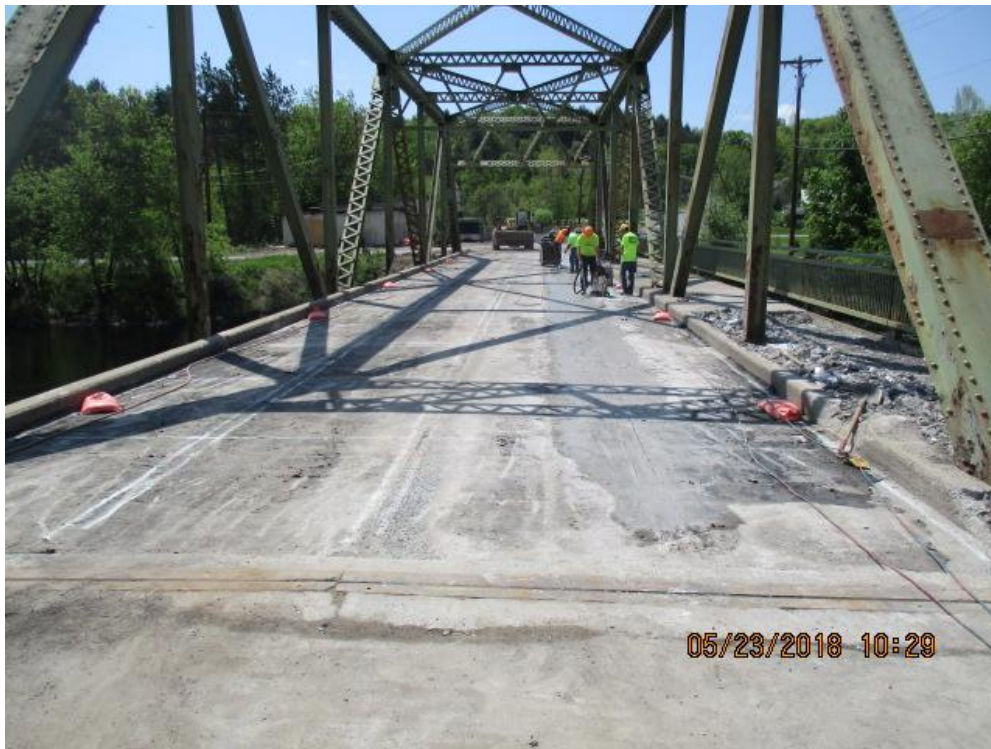
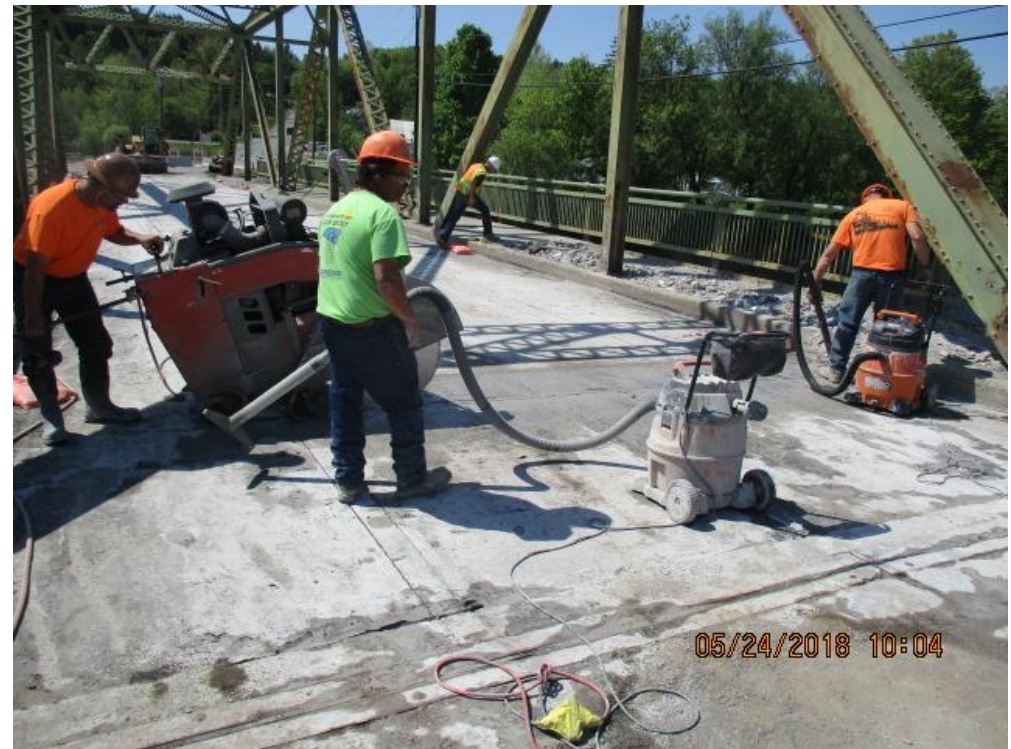
Bridge Demolition

Sawcutting the Deck

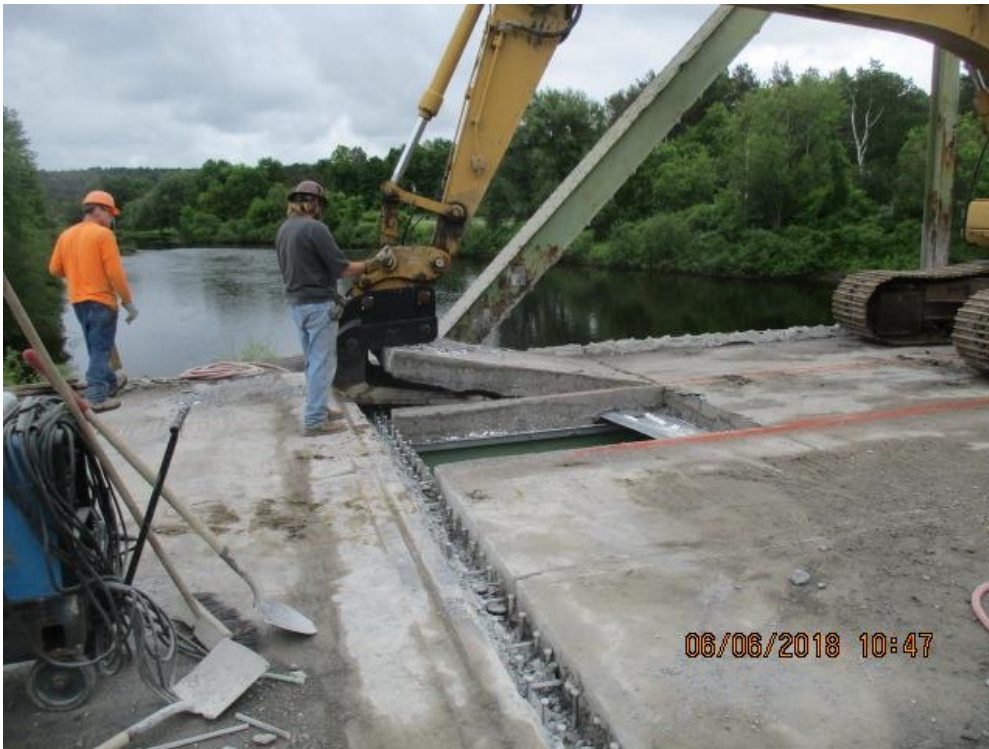
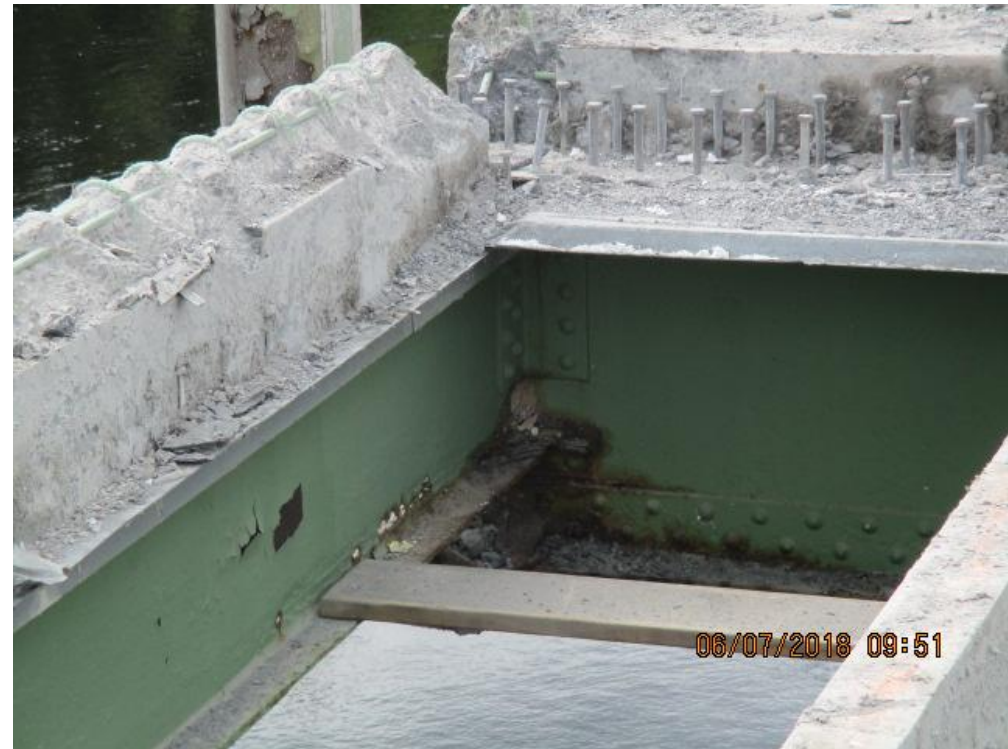
Bridge Demolition

Removing deck panels

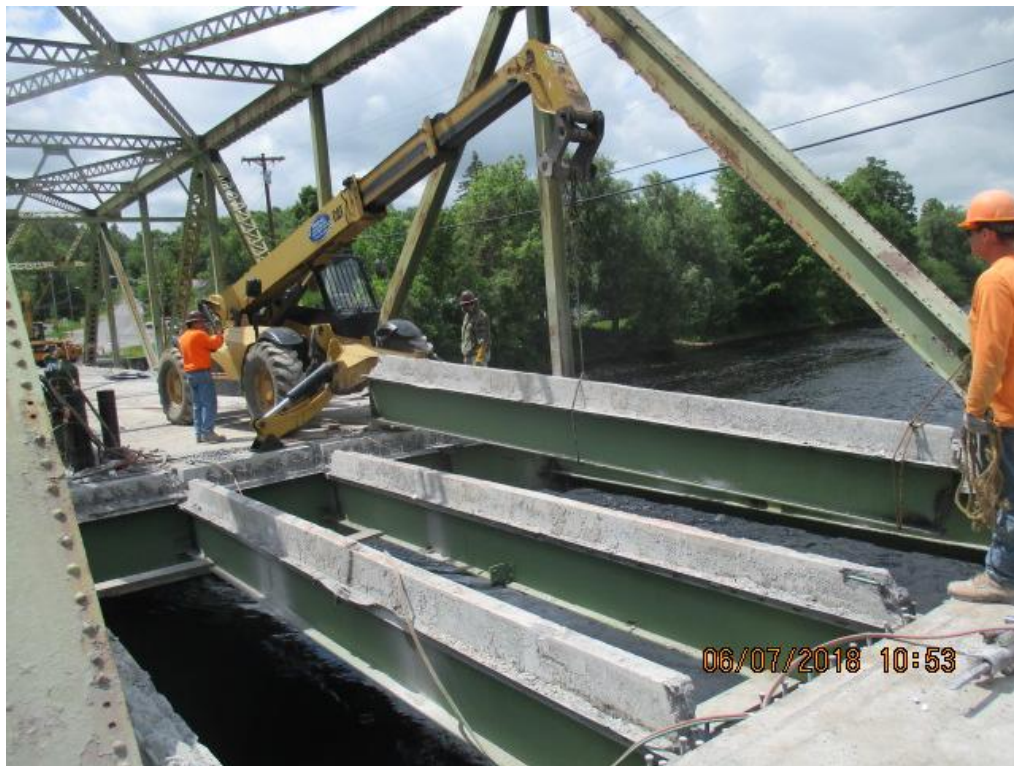
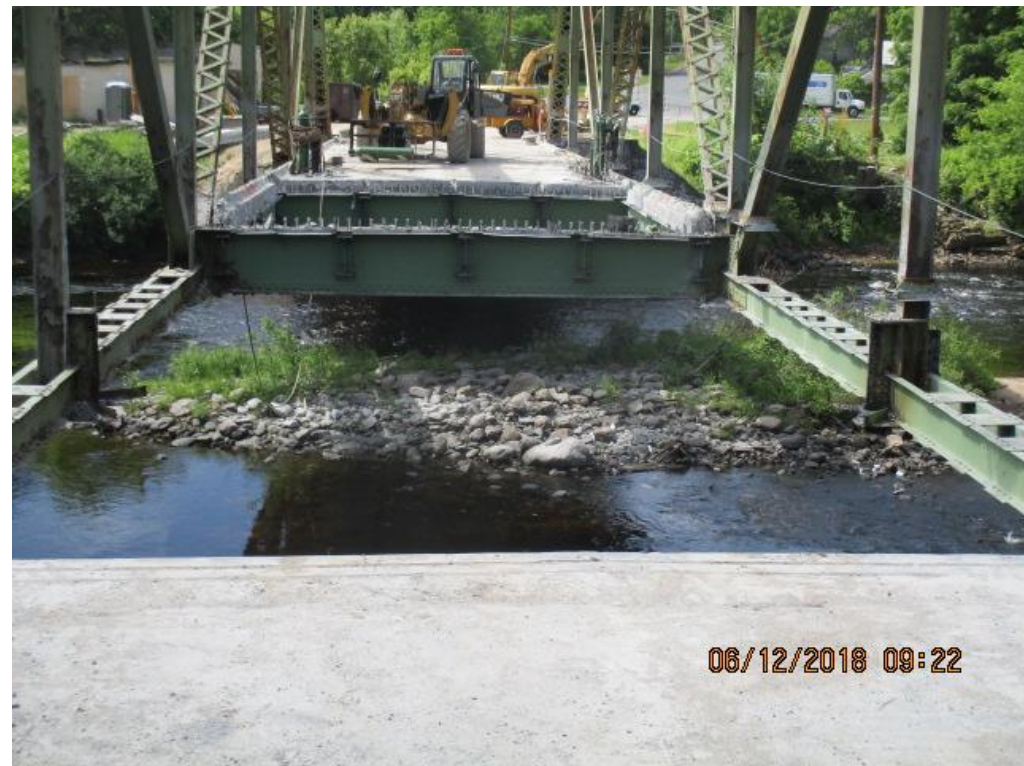
Bridge Demolition

Removing longitudinal stringers

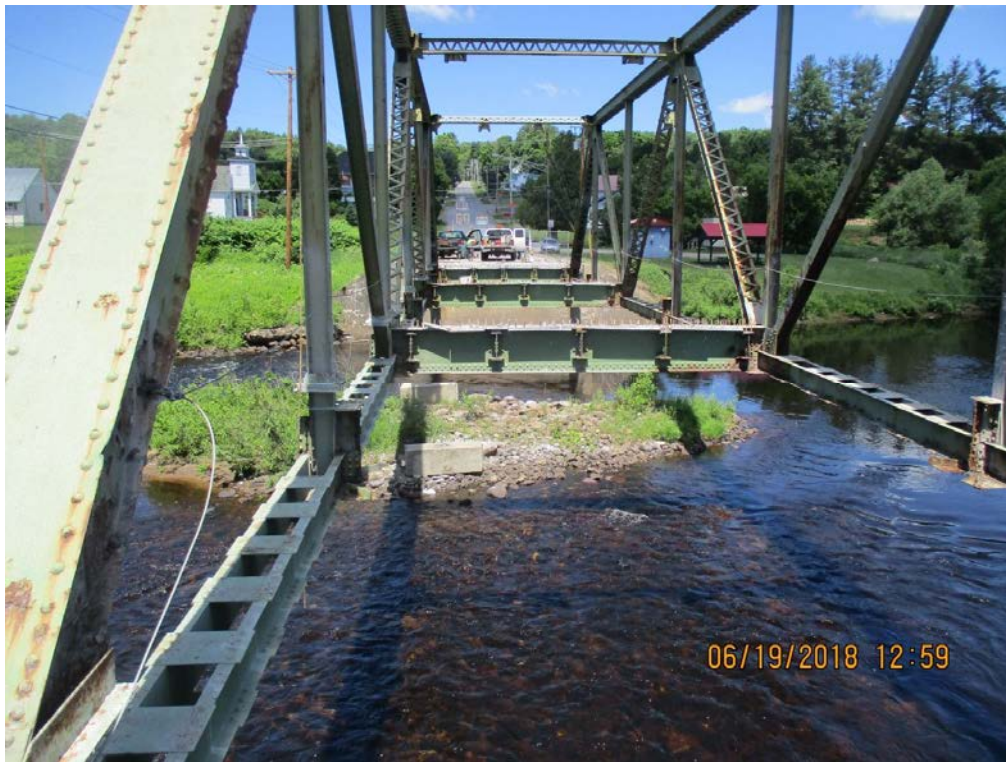
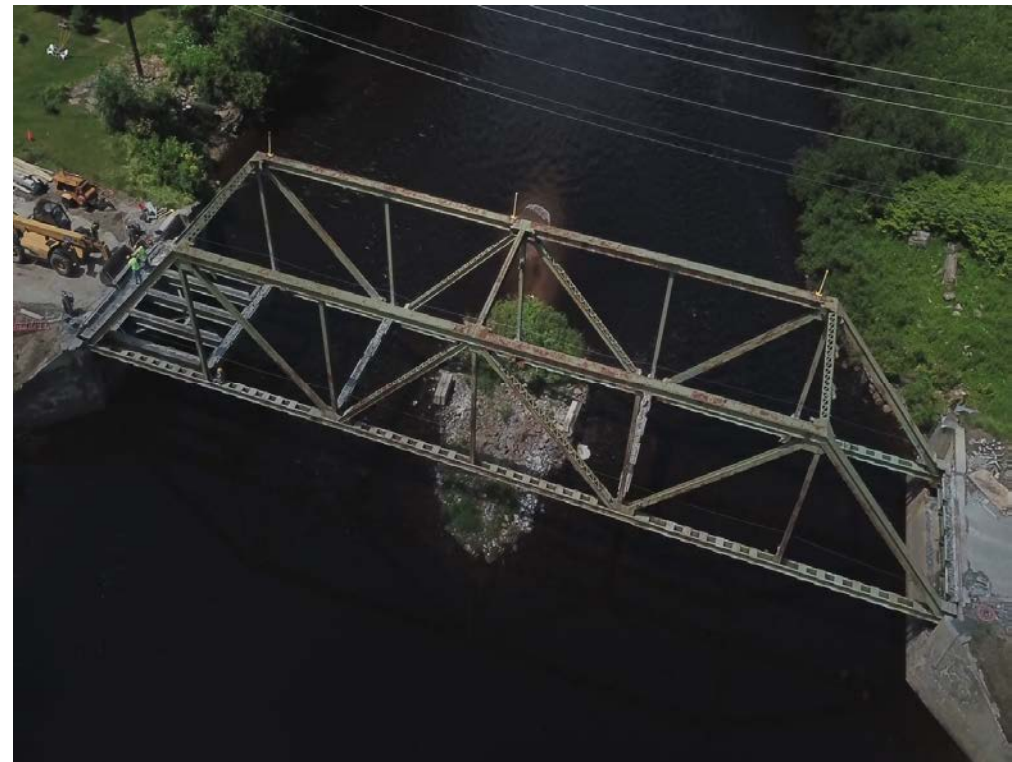
Bridge Demolition

Truss ready to be picked

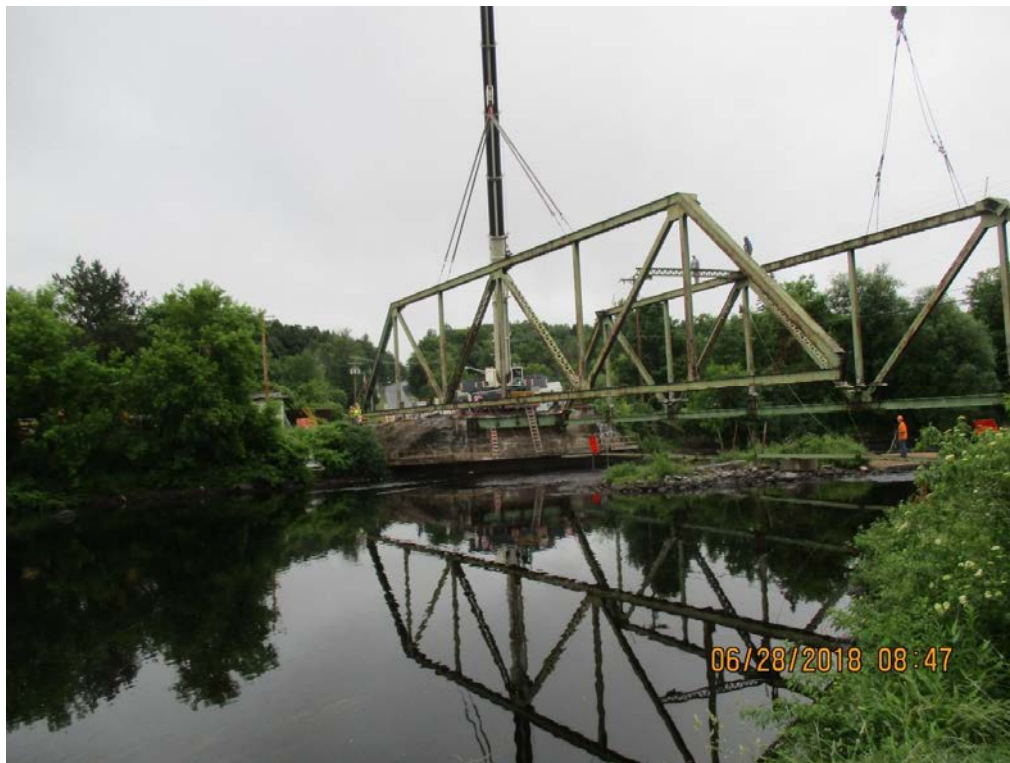
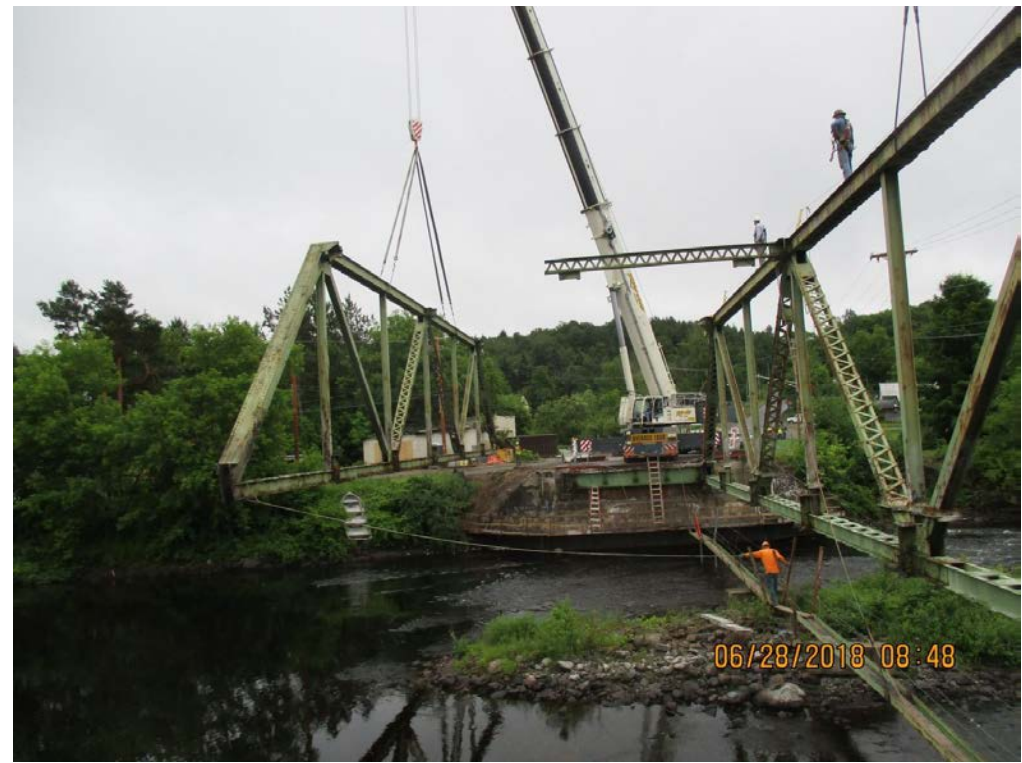
Bridge Demolition

Truss removal (400T and 80T crane)

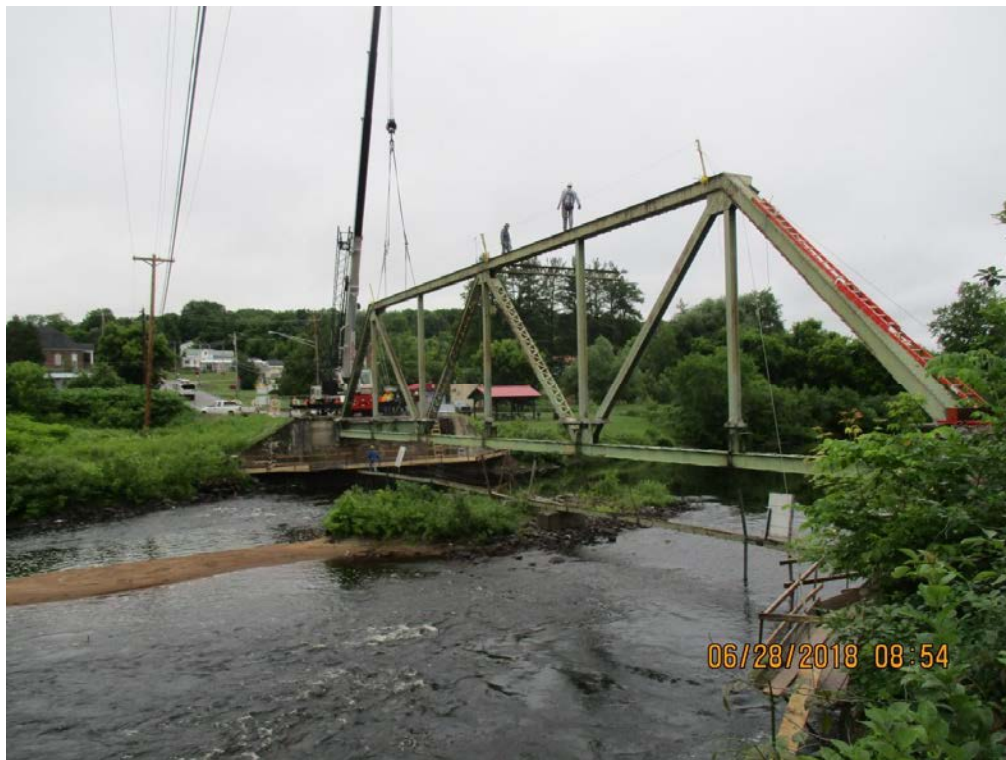
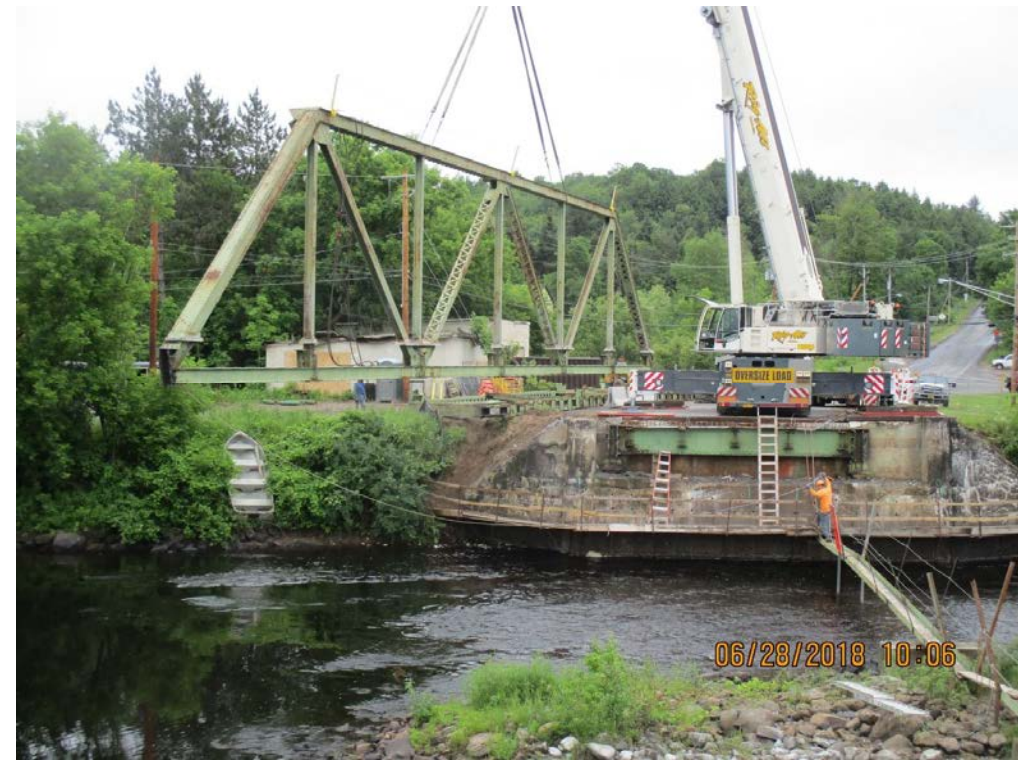
Bridge Demolition

Truss removal (400T and 80T crane)

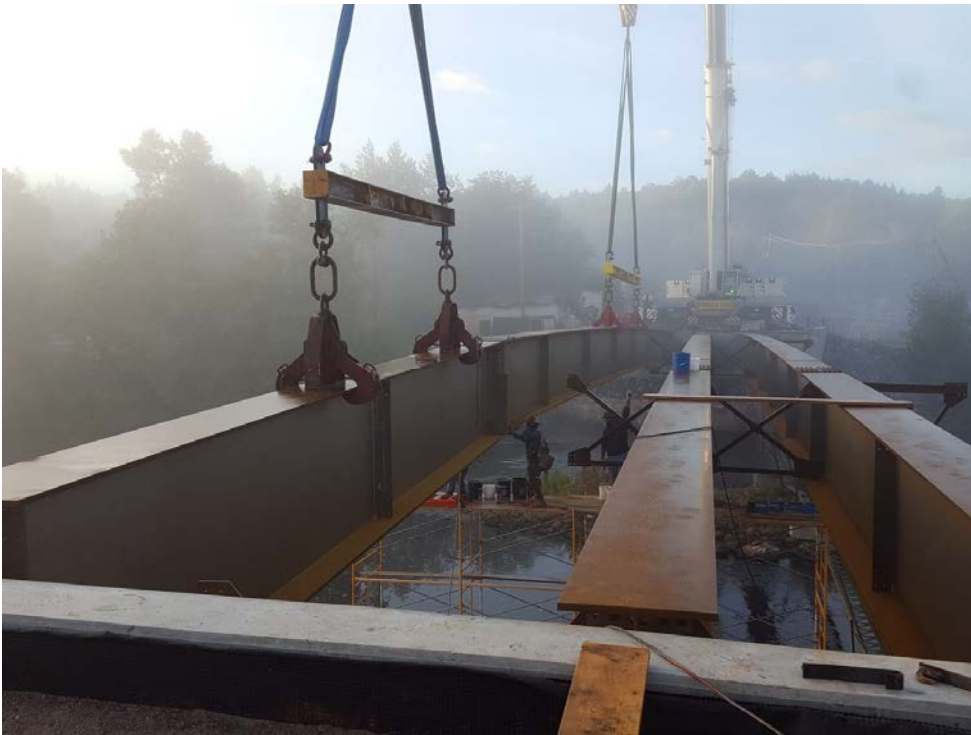
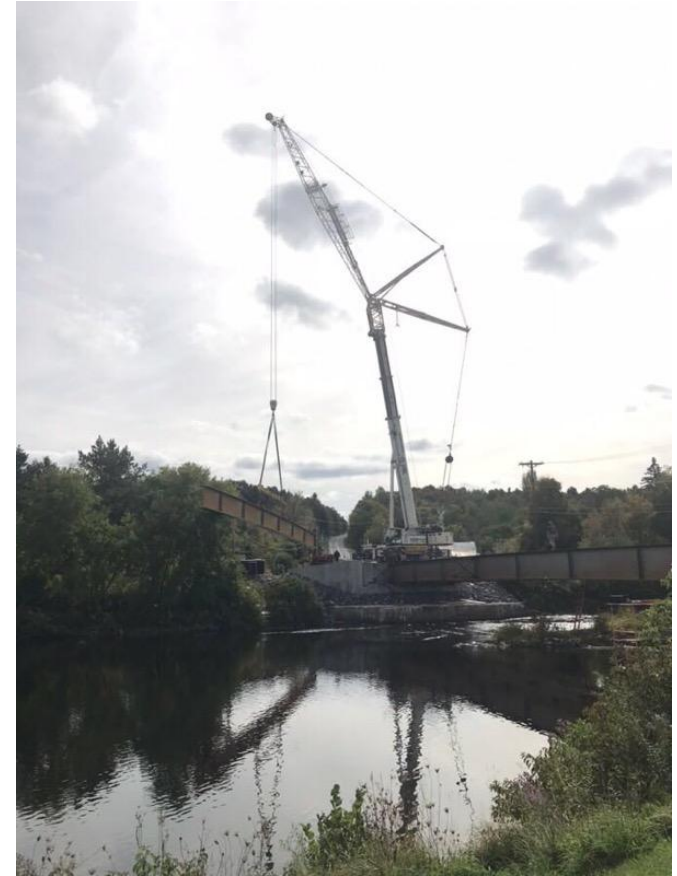
Steel Erection

- September 2018 – Set steel girders

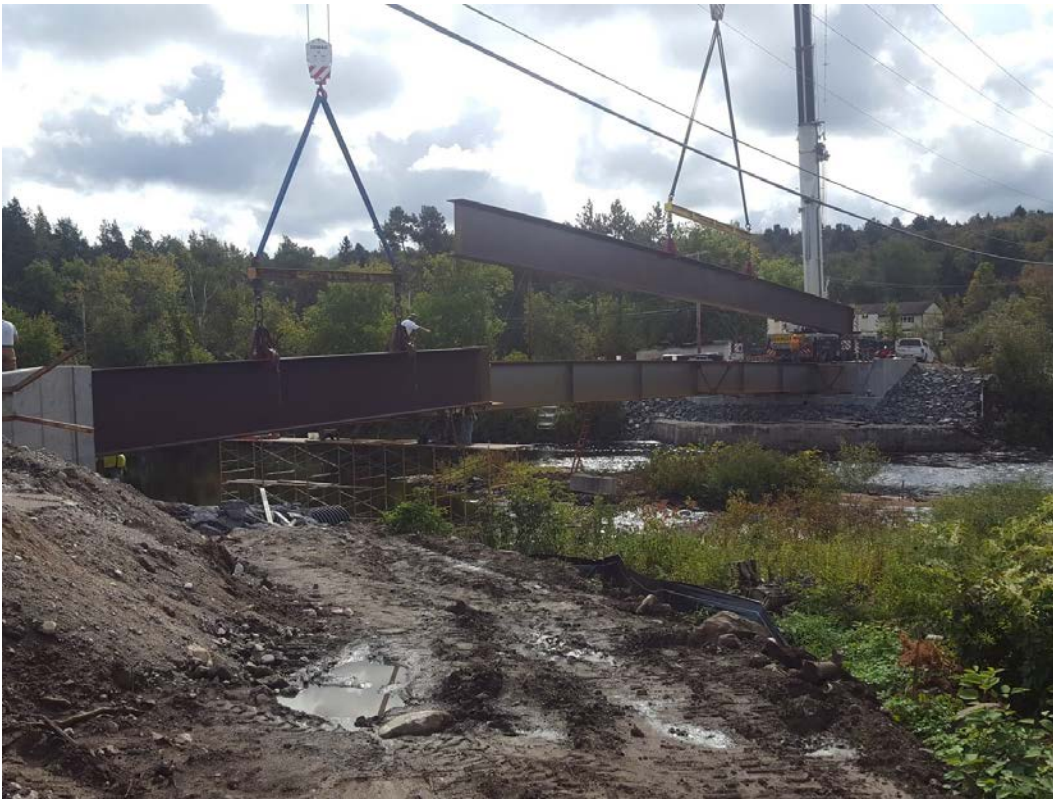
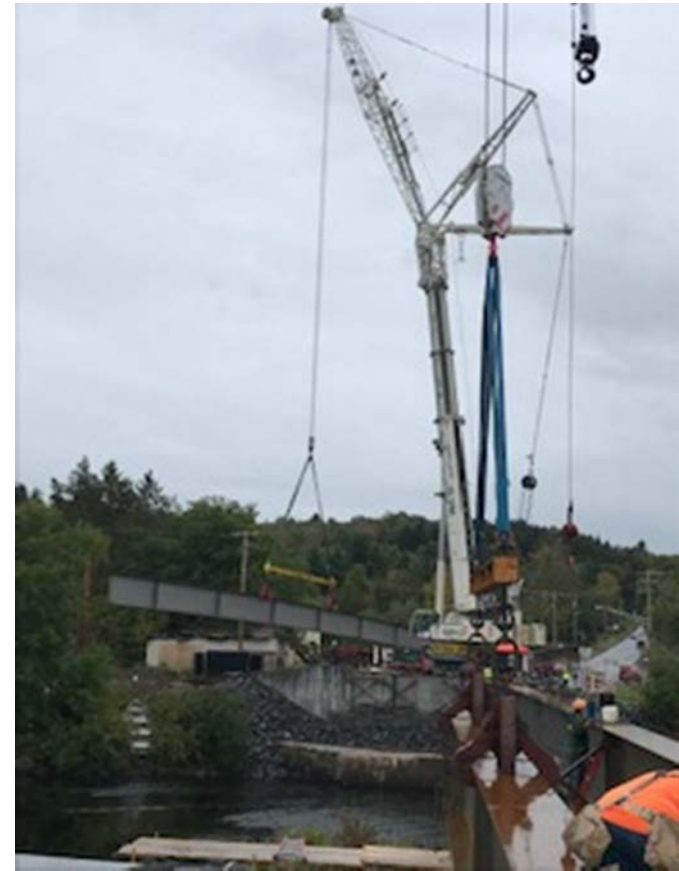
Steel Erection

- 3 Crane Setup (400T, 250T, 80T)

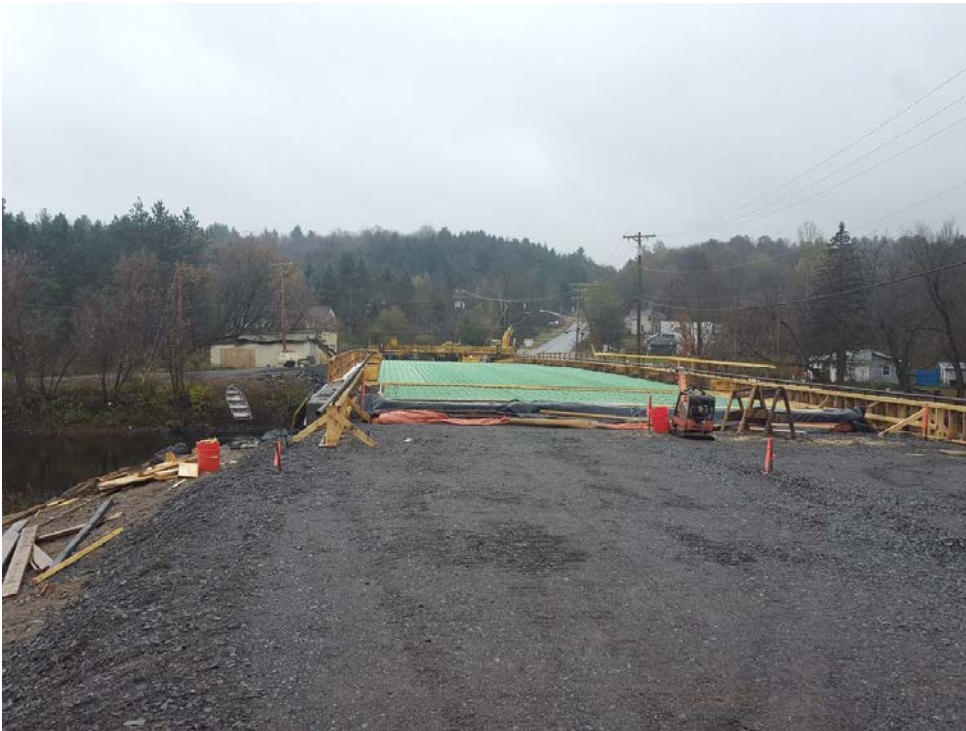
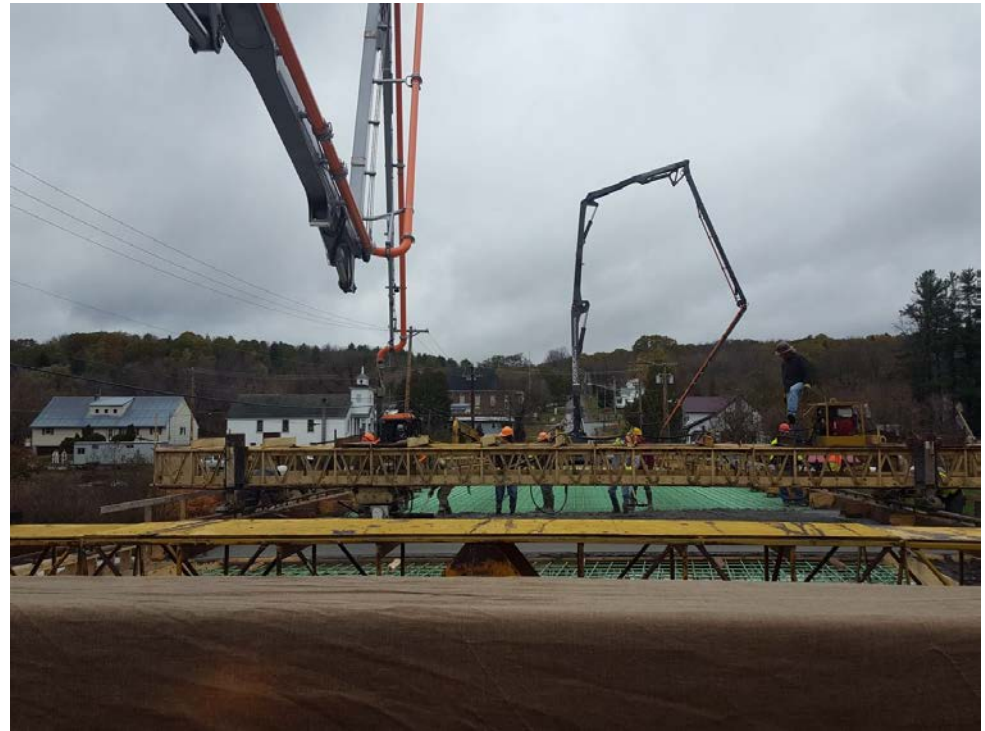
CIP Deck

- October 2018 – Placed CIP deck
