Permitting the Replacement of Loring Crossing Bridge over the East Branch of the Tioughnioga River

PRESENTED BY:
 Johanna E Duffy, CWB®, PWS – Barton & Loguidice, DPC
 Zachary P Dale, I.E. – Barton & Loguidice, DPC

NYSDEC permitting process and mitigation efforts for recent Cortland County Project

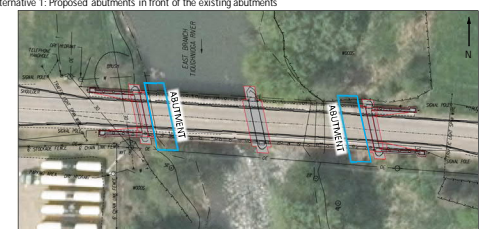
Alternative 1: Proposed abutments in front of the existing abutments

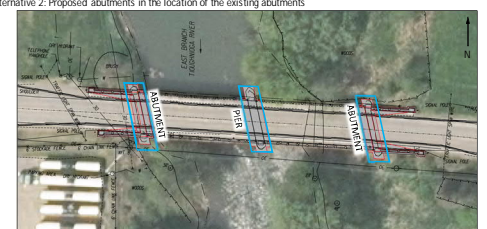
Alternative 2: Proposed abutments in the location of the existing abutments

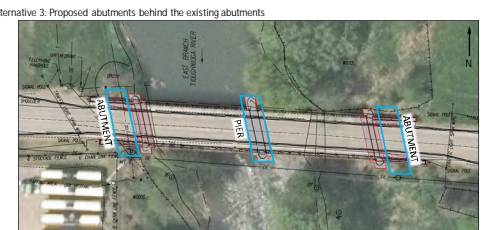
Alternative 3: Proposed abutments behind the existing abutments

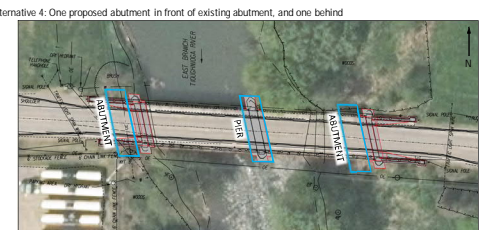
Alternative 4: One proposed abutment in front of existing abutment, and one behind

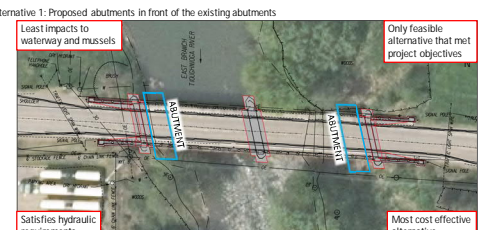
Alternative 1: Proposed abutments in front of the existing abutments

Least impacts to waterway and mussels

Only feasible alternative that met project objectives

Satisfies hydraulic requirements

Most cost effective alternative

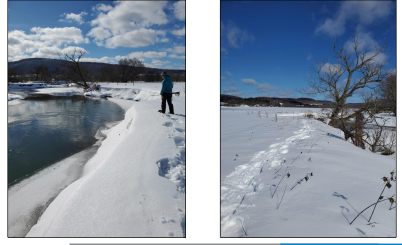
Existing Condition

- Riparian Buffer Mitigation Site
 - 550 linear feet, 15-20 feet in width
- Buffer plantings – Cortland County Soil & Water Conservation District
 - 59% shrubs – bare root seedlings and unrooted live stakes
 - 41% trees – bare root seedlings
- 3-year monitoring period

Legend:
 Existing Milewide
 15-20 ft Buffer Mitigation Stakes
 Riparian Seedlings
 (Tree, Shrub)
